NSWCCD-TR-61—97/10

Survivability, Structures, and Materials Directorate  
Technical Report

## SEM Stereo-Section Fractography Observations

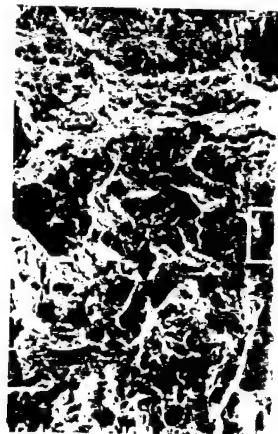
The location of the fatigue precrack tip and cleavage initiation sites with respect to the banding structure for this specimen were determined using the SSF technique in the usual manner. A low-magnification SEM fractographic view (Figure 5a) was first used to identify the MCIR of specimen BB10, and then the transverse section was prepared. The left-hand portion of the fracture surface after sectioning (Figure 5b) illustrates that the section plane is within 5  $\mu m$  from the MCIS. After etching and tilting the specimen 30° (Figure 5c), the banded microstructure at the MCIS is clearly visible. Slowly rotating the specimen while identifying

Figure 5b: A conventional SEM fractograph of specimen BB10 after sectioning.

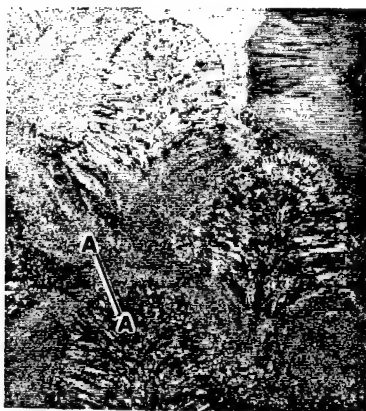
Figure 8a illustrates the weld bead microstructure of specimen GXK 62. The microstructure surrounding the fusion line of one bead (A-A in Figure 8a) has been magnified in Figure 8b. In this picture, the FGHAZ, CGHAZ, fusion line, and the edge of the CCZ are evident. It is important to note the similarity between the CGHAZ and the edge of the CCZ adjacent to the fusion line: both contain allotriomorphic ferrite along the prior austenite grain

Figure 8a: The weld bead structure of specimen GXK 62.

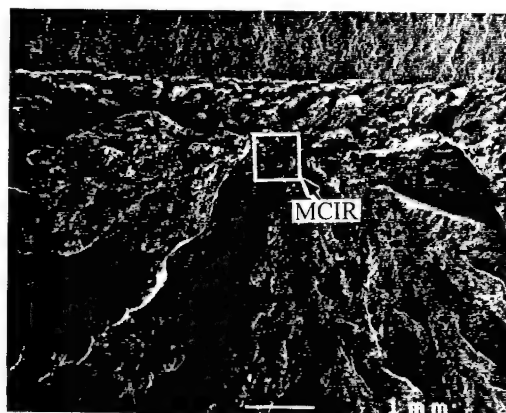
The SSF results indicated that the MCIS in four of the five sectioned GXK specimens was located at the edge of the CCZ, adjacent to the fusion line. Specimen GXK 62 is typical of these specimens. The unsectioned fracture surface of this specimen (Figure 9a) clearly indicates the dominant CIS. The focal point of the site (within the white box in Figure 9a) is enlarged in Figure 9b and the cleavage initiation site has been identified by the black arrow. A transverse section was then prepared approximately 10  $\mu\text{m}$  from the cleavage initiation site. Figure 9c shows the fracture surface and transverse section simultaneously after tilting the specimen 45° about the sectioning axis. In the figure, the small triangular cleavage facet near the cleavage initiation site (indicated by black arrow) was used to identify the location of the MCIS as the section was rotated to view solely the transverse microstructure surrounding the CIS and fatigue precrack (Figure 10). It is evident in Figures 9c and 10 that cleavage initiation was associated with long ferrite plates at the edge of the CCZ, adjacent to the fusion line. Further, it is evident that (1) the tip of the fatigue pre-crack was located in the middle of the CCZ; (2) ductile crack growth proceeded through the CCZ for approximately 1 mm without triggering cleavage cracking; and (3) cleavage was triggered only when the edge of the CC microstructure was sampled by the crack tip. As mentioned earlier, four of the five GXK specimens examined also exhibited cleavage initiation only within the CCZ, near the edge of the fusion line.

Figure 9a: A low magnification conventional SEM fractograph of specimen GXK 62.

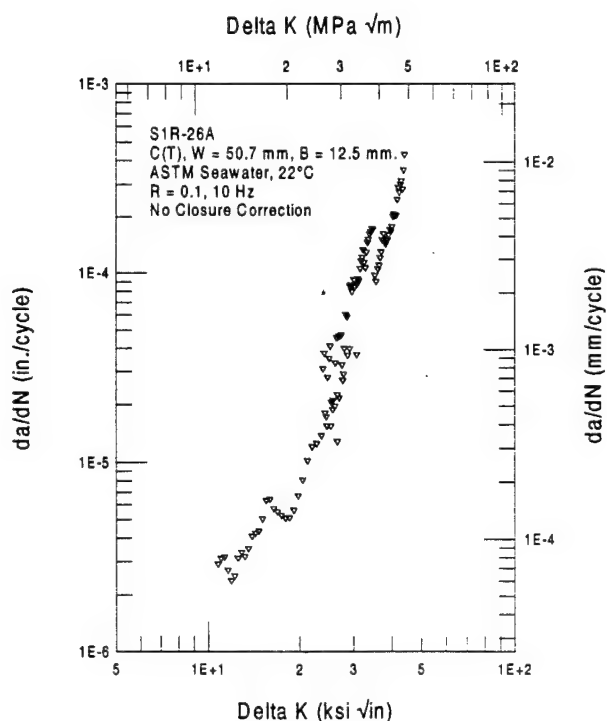
Figure 12

The SSF technique was also applied to study the cracking behavior of a Ti6Al-4V forging. This material was tested in 3.5% NaCl at room temperature under constant amplitude,  $R=0.1$  loading. The fatigue crack growth rate (FCGR) behavior was highly nonuniform and exhibited sporadic crack growth acceleration and deceleration, especially between  $10 \text{ MPa}\sqrt{\text{m}} < \Delta K < 20 \text{ MPa}\sqrt{\text{m}}$  (Figure 12). Fractographic observation revealed three distinct features on the fatigue surface which contribute to this behavior (Figure 13a): (I) coplanar faceted regions; (II) brittle, randomly-oriented faceted regions; and (III) peculiar transverse regions featuring crystallographic facets and out-of-plane steps or jogs. An enlargement of one of these areas (Figure 13b) illustrates one of the peculiar surface feature III regions.

Figure 12: Fatigue crack growth rate behavior of Ti6Al4V forging: specimen SIR-26A.

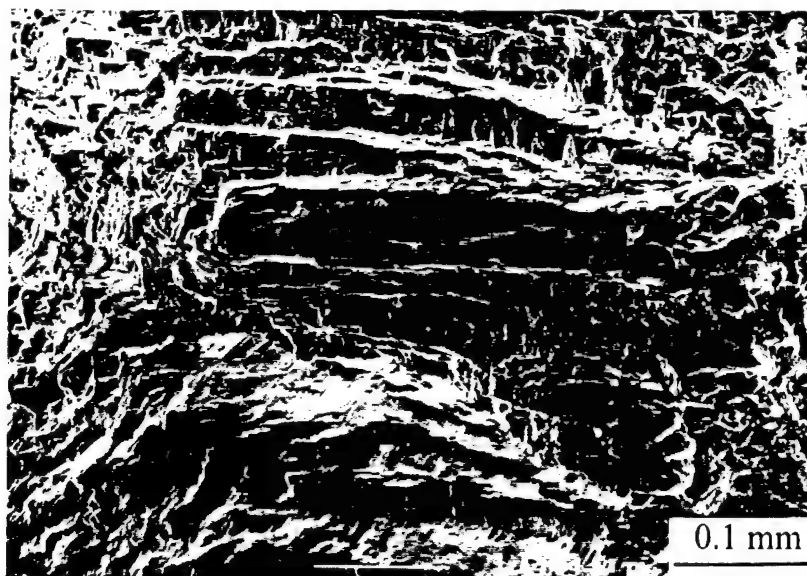
Figure 13b. An enlargement of the boxed area in Figure 13a.
